N J NO NAME DAM

NO 20

NJ 00472

PHASE 1 INSPECTION REPORT  
NATIONAL DAM SAFETY PROGRAM

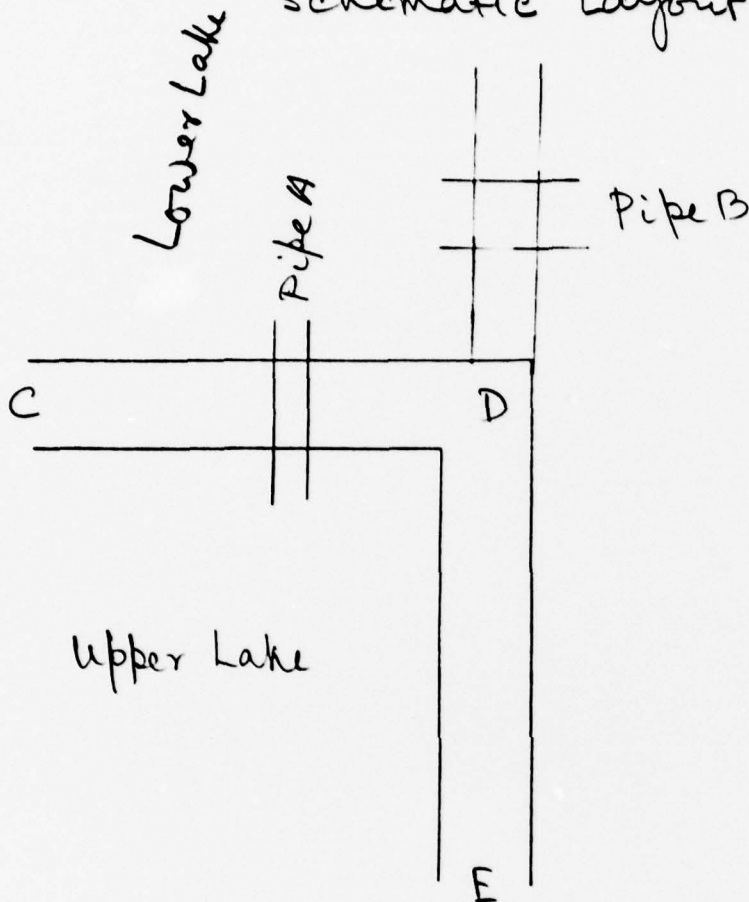
### Schematic Layout of Dam

- ① Upper lake and Lower lake are separated by the road CD
- ② When the Road CDE is overtopped there is no attenuation in the lower lake
- ③ Storage in the upper lake is effective in routing.
- ④ Outflow through pipe A is similar to spillway discharge in Dam Inspection Study.

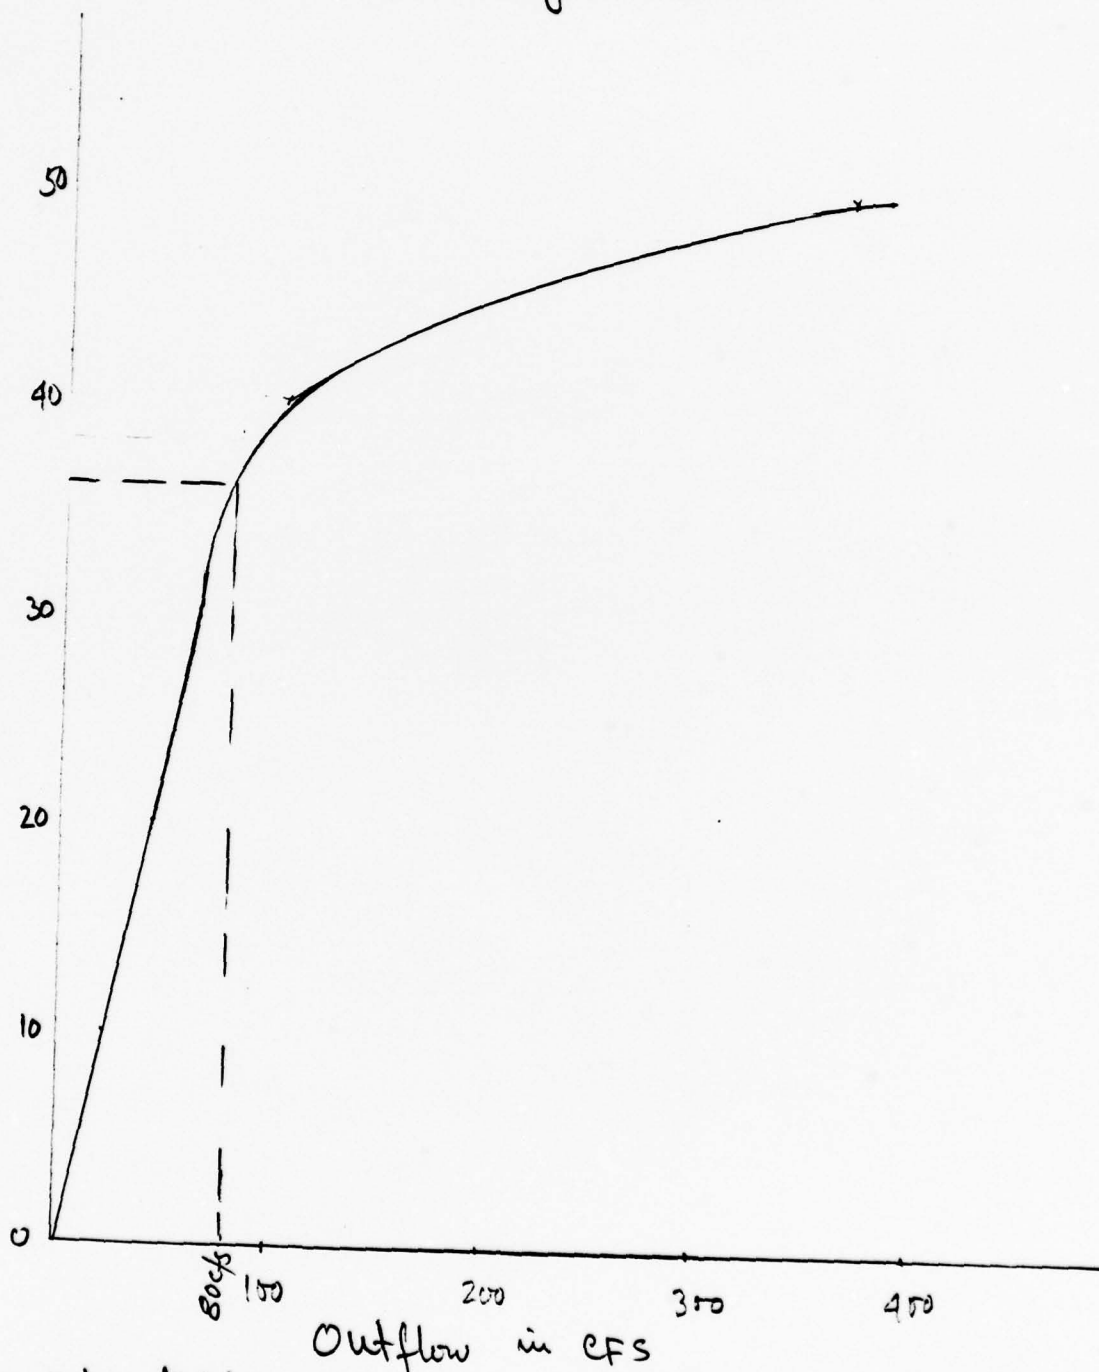
## Overtopping Potential

Overtopping of Dam occurs at EL 562.95  
 $Q = 80 \text{ cfs}$  (36% of PMF)
